RESEARCH MEMORANDUM

FLIGHT MEASUREMENTS OF THE LONGITUDINAL STABILITY AND CONTROL

CHARACTERISTICS OF THE GRUMMAN F8F-1 AIRPLANE --

TED NO. NACA 2379

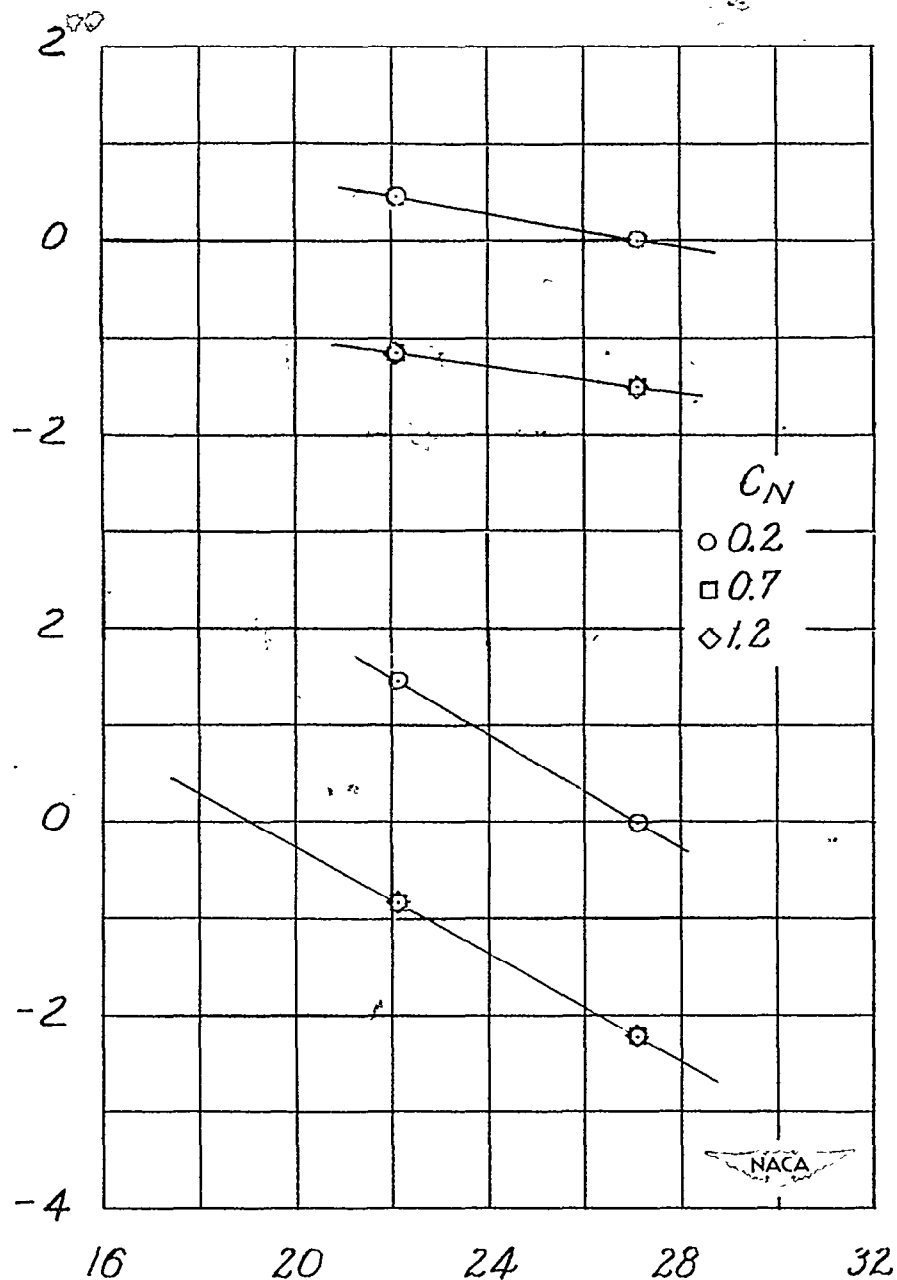
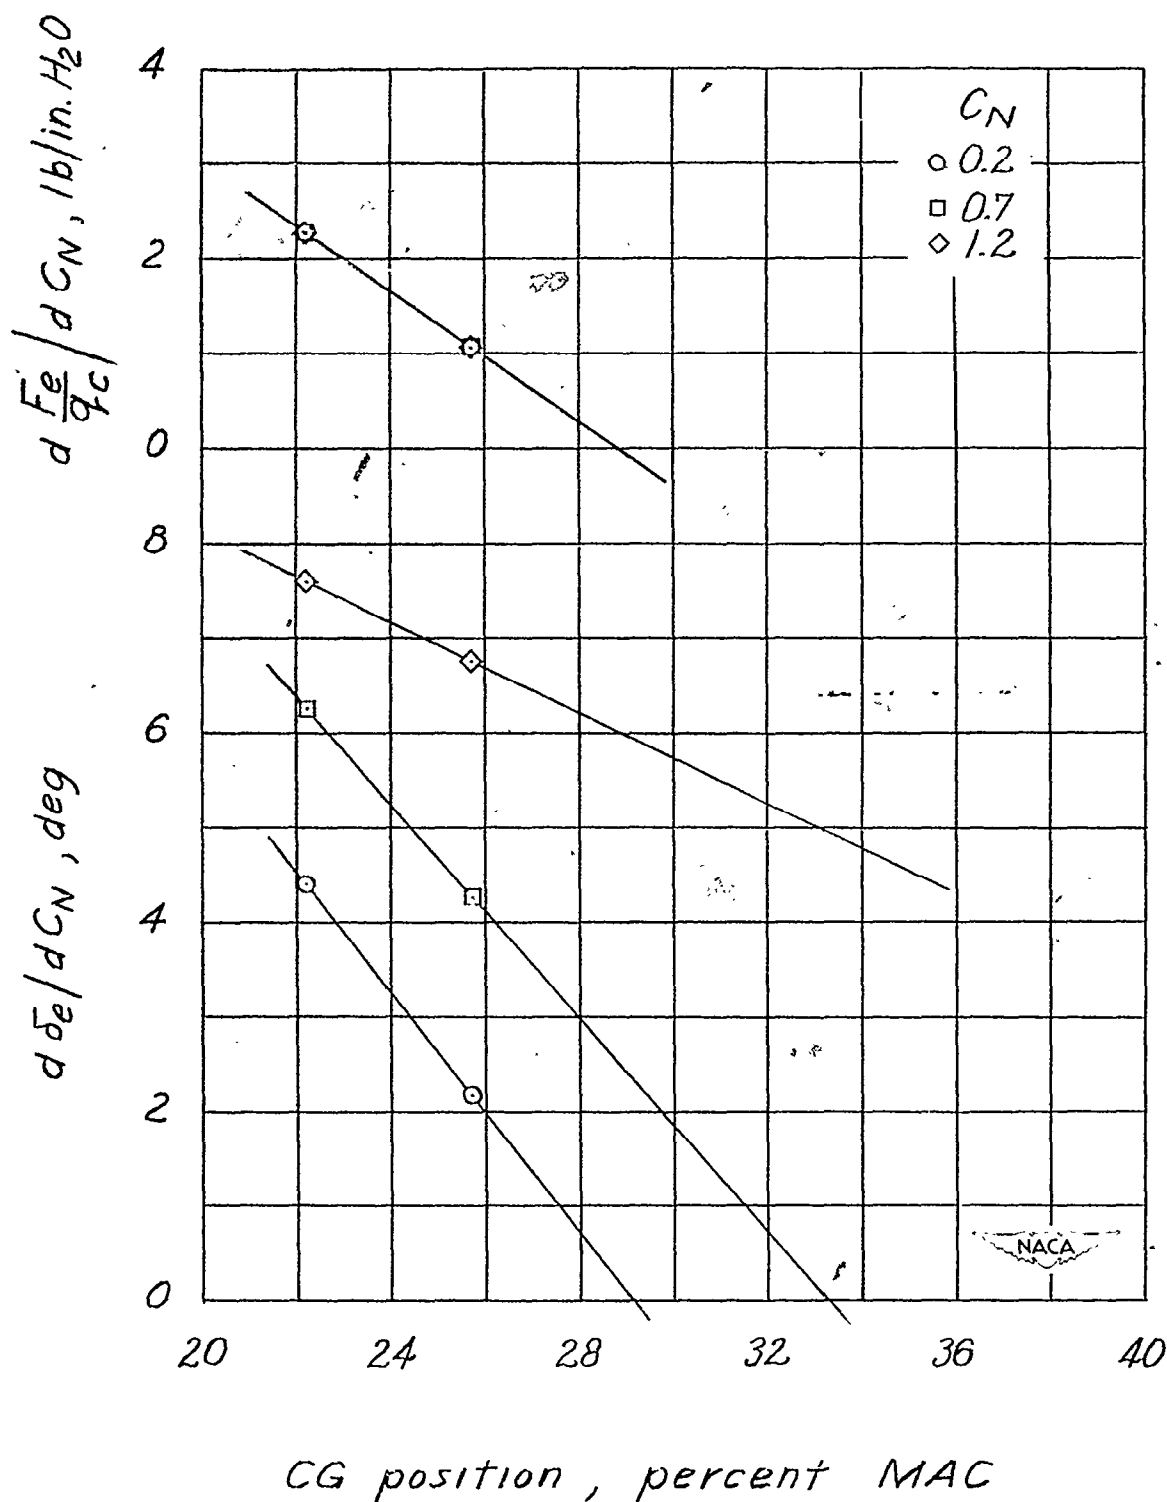
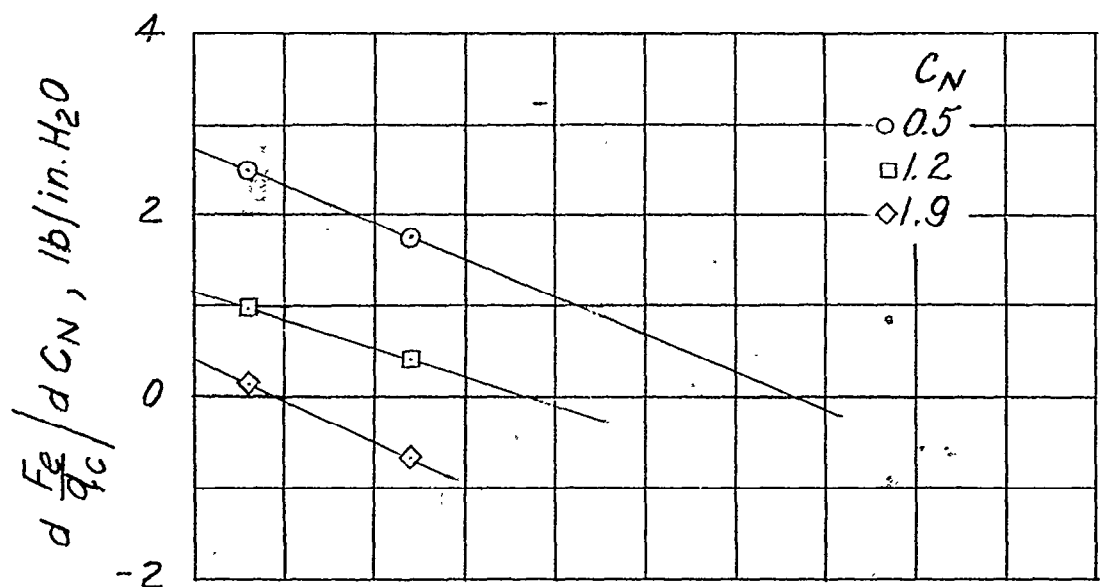
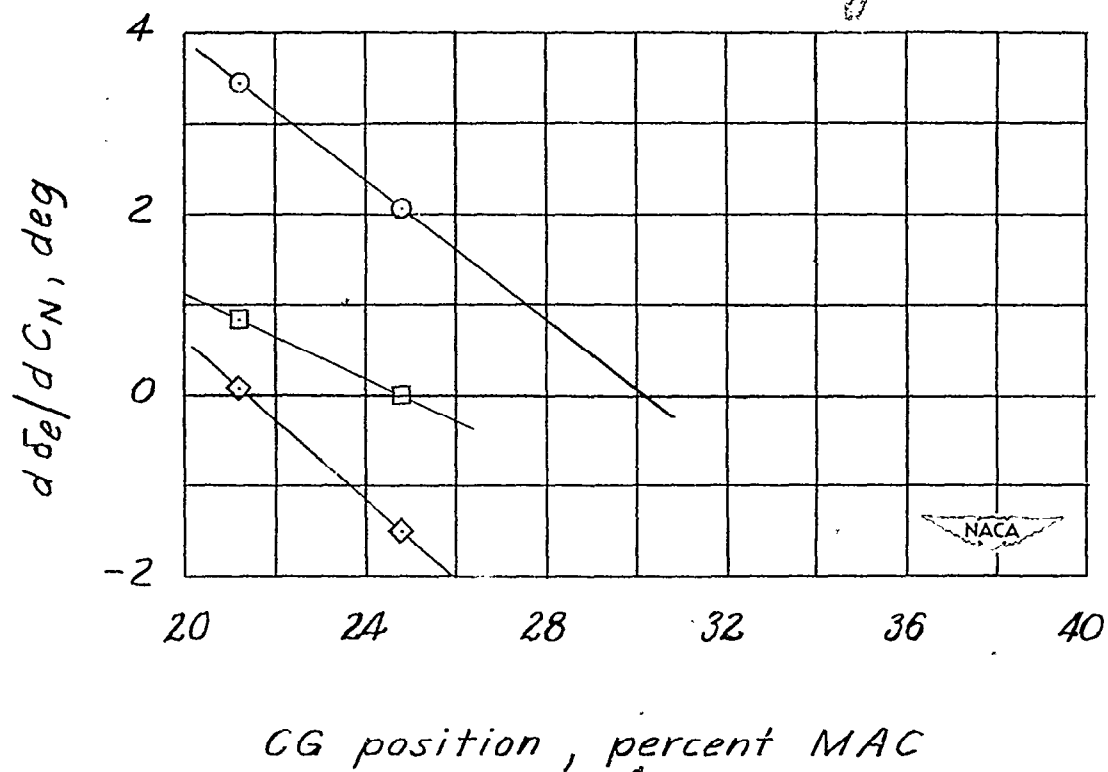
(a) Rated-power clean condition.

Figure 9.- Determination of stick-fixed and stick-free neutral points, Grumman F8F-1 airplane.

(b) Gliding condition.

(c) Power-approach condition.

Figures 5 to 7 contain plots of the variation of elevator angle, elevator control force, and sideslip angle in straight flight against calibrated airspeed. For this series of tests, the pilot held the airplane at essentially zero angle of bank and, therefore, laterally level flight can be assumed. Plots of the variation of the elevator angle with normal-force coefficient and the variation of elevator force divided by the impact pressure F_e/q_c with normal-force coefficient are presented in figure 8 for the three conditions tested. The stick-fixed and stick-free neutral points were determined from the slopes of these curves. The neutral points for a given lift coefficient are defined as the center-of-gravity positions at which the slopes $\frac{d\delta_e}{dC_N}$ and $\frac{dF_e/q_c}{dC_N}$ are zero. The determination of the neutral points in the rated-power clean, gliding, and power-approach conditions for several normal-force coefficients is shown in figure 9. Figure 10 shows the variation of stick-fixed and stick-free neutral points with normal-force coefficient.

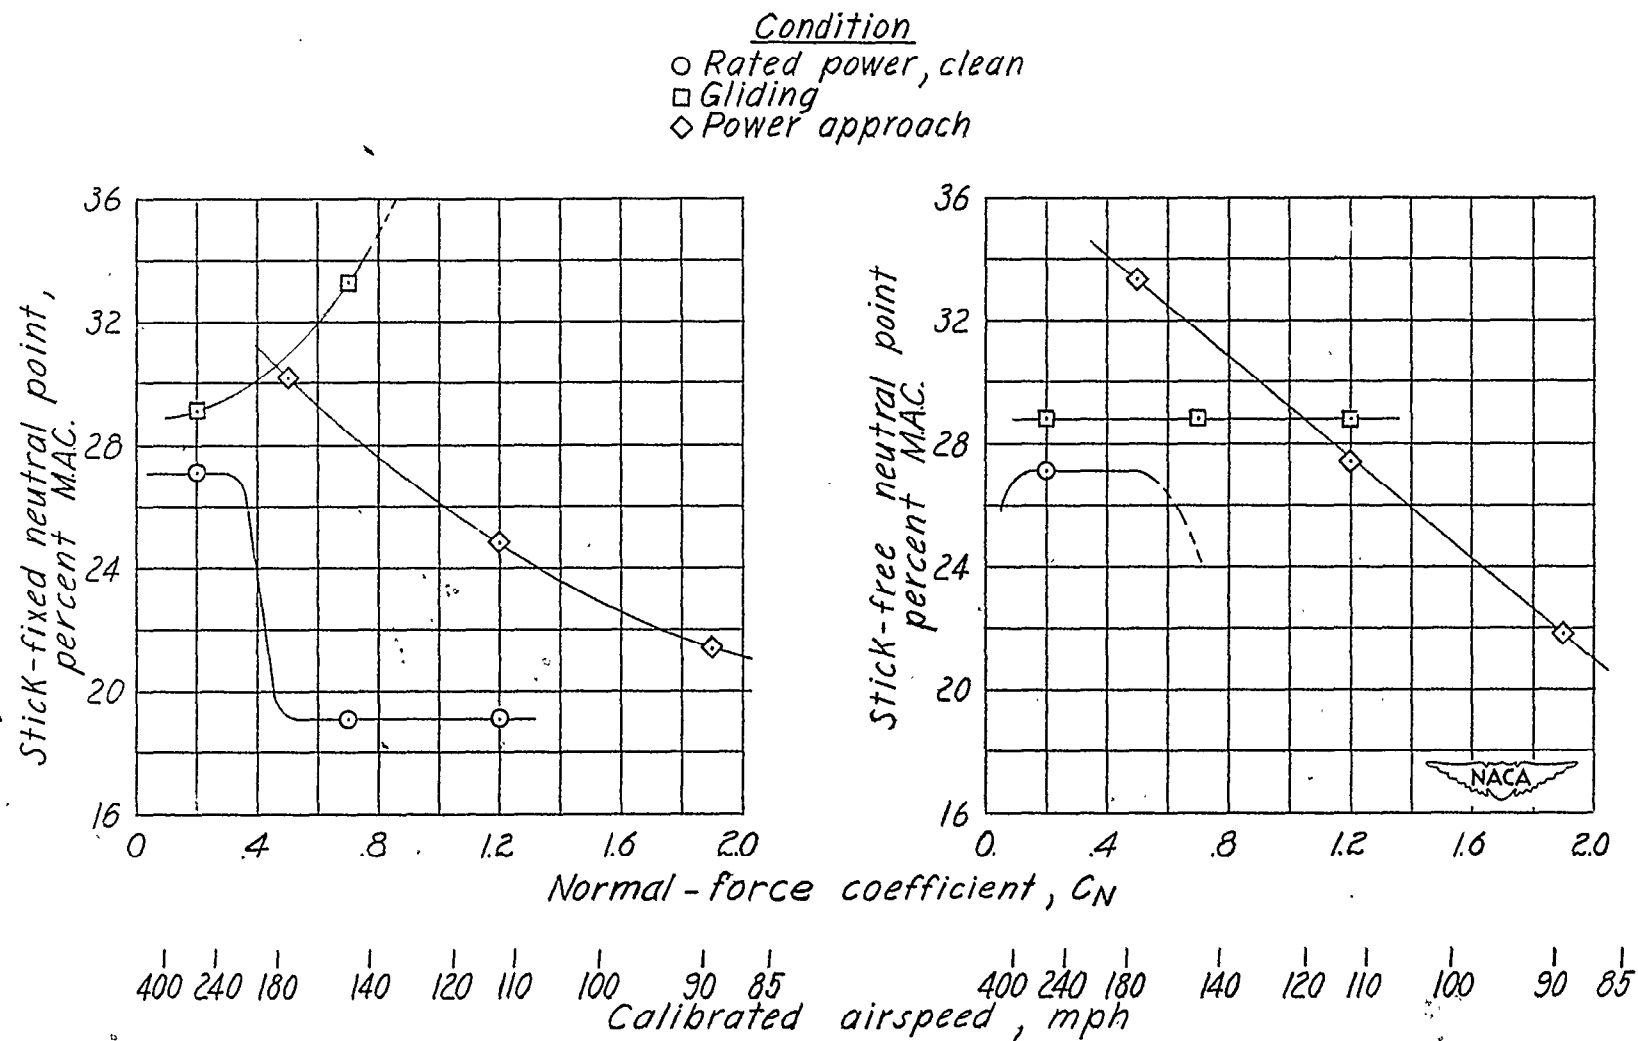
Figure 10.- Summary plots of the variation of the neutral points with normal-force coefficient, Grumman F8F-1 airplane..

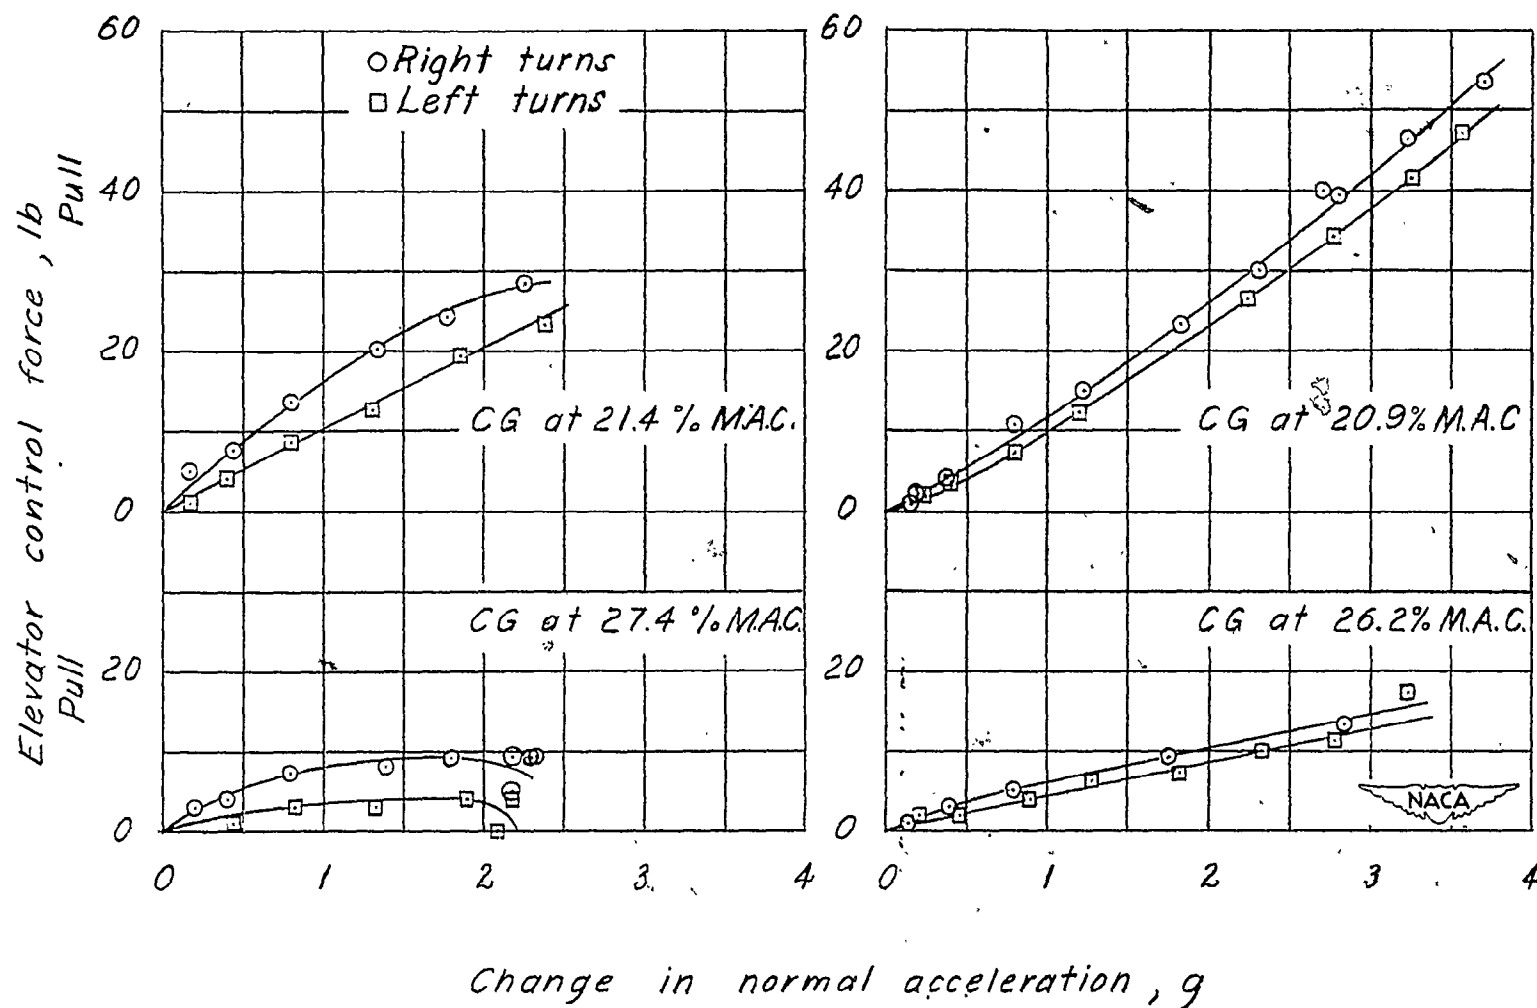
(a) 200 mph.

(b) 350 mph.

Figure 11.- Variation of elevator control force with change in normal acceleration for constant airspeed turns in the rated-power clean condition, Grumman F8F-1 airplane.

The longitudinal stability and control characteristics in accelerated flight were investigated in right and left turns made in the rated-power clean condition at an altitude of approximately 10,000 feet. Spot records were obtained in steady turns at 200 and 300 miles per hour at various accelerations. Figure 11 presents curves of the variation of elevator control force with normal acceleration at each speed for two center-of-gravity positions, while figure 12 shows the variation of elevator angle with airplane normal-force coefficient in the turns.

However, in the case of the aft center-of-gravity position (27.4 percent M.A.C.) and the lower speed, the elevator control force became zero at the highest accelerations reached (fig. 11). The pilot considered this condition very objectionable and the requirement of reference 3 which states that the elevator control-force gradient in steady turns shall never be less than 3 pounds per g was not satisfied.

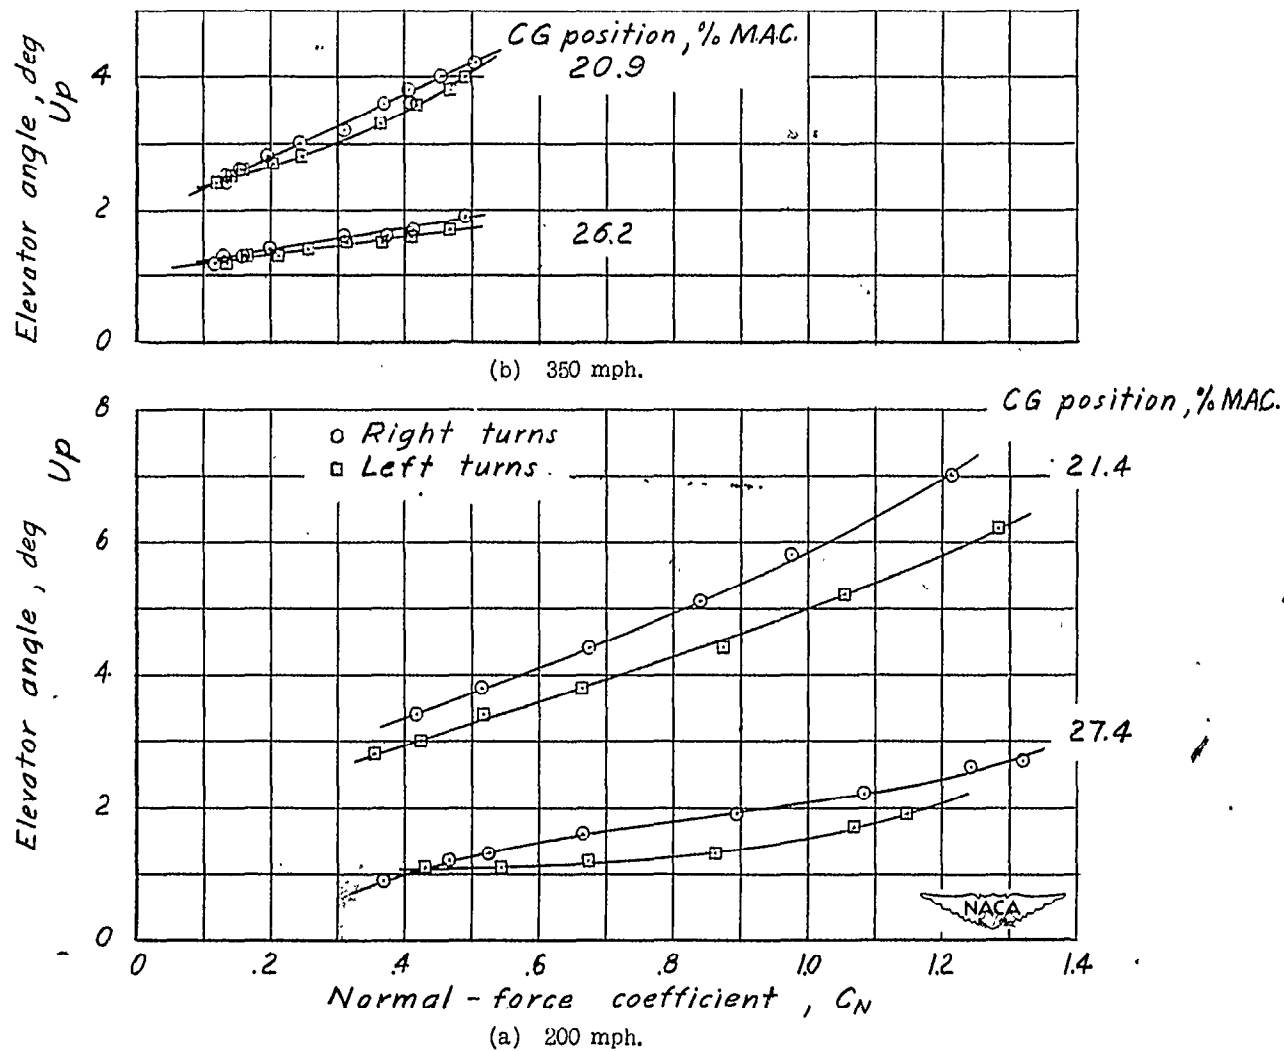
Figure 12.- Variation of elevator angle with normal-force coefficient for constant airspeed turns in the rated-power clean condition, Grumman F8F-1 airplane.

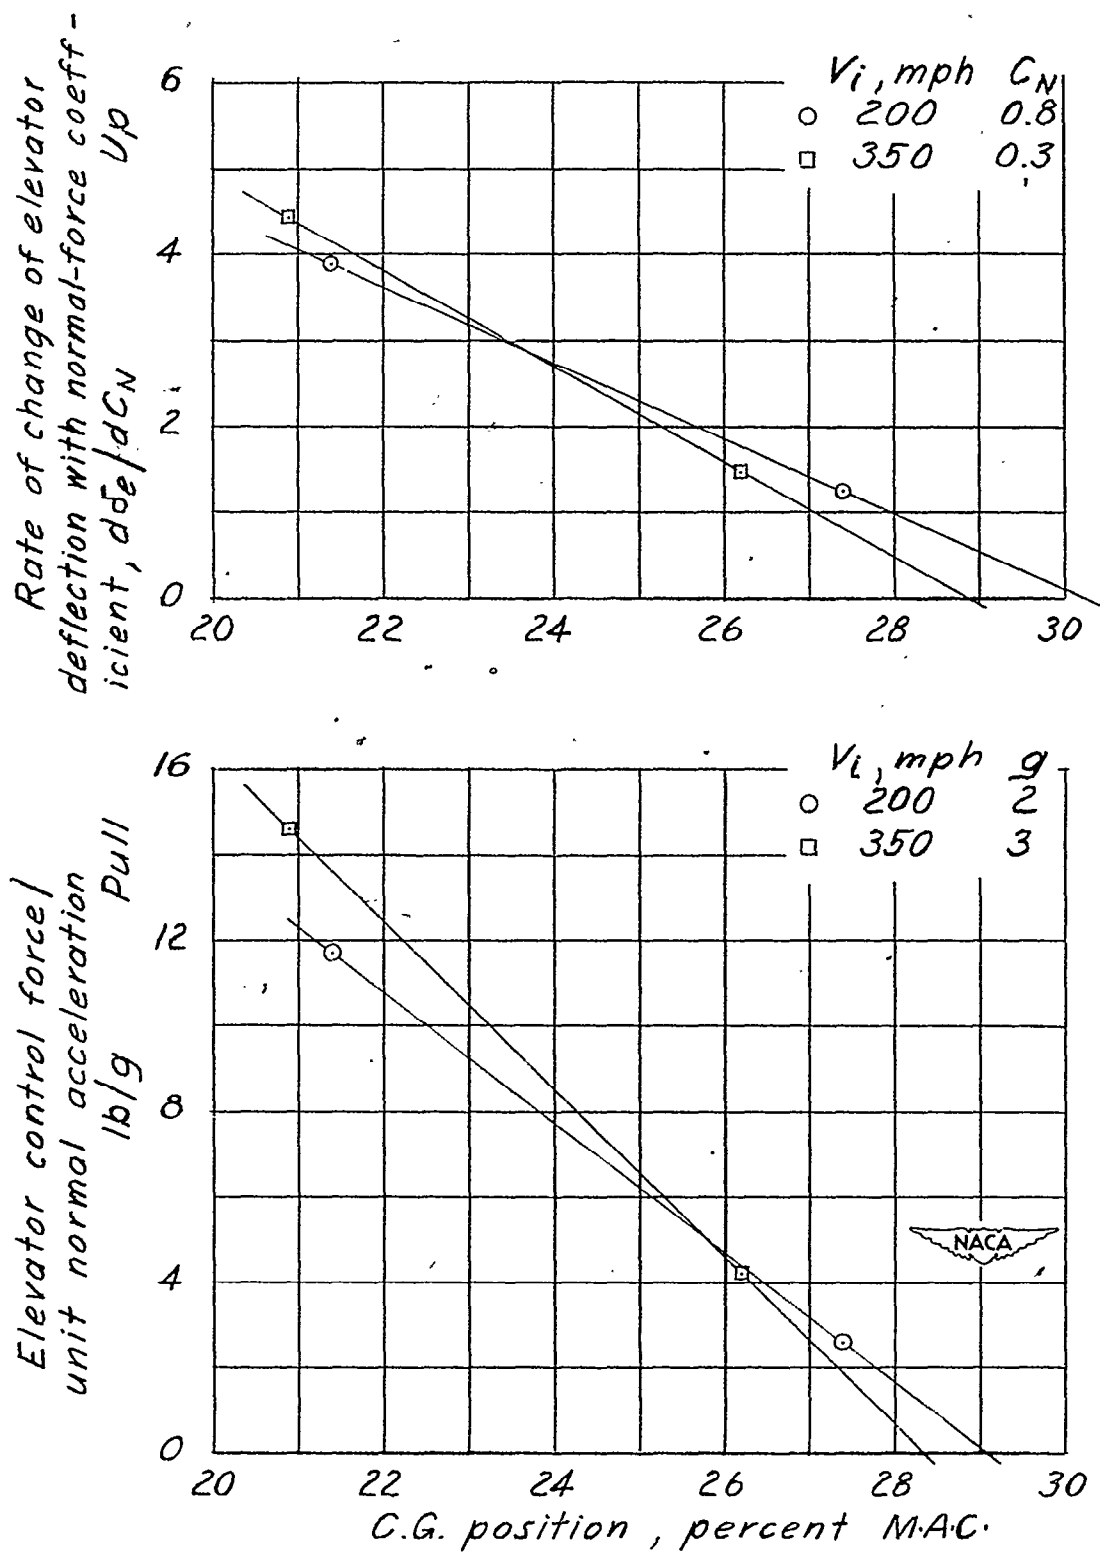
Figure 13.- Determination of maneuver points for the rated-power clean condition, Grumman F8F-1 airplane.

The stick-fixed maneuver points were determined for a normal-force coefficient at the middle of the range covered for each speed as the center-of-gravity position where values of the slope $d\delta_e/dC_N$ are zero in figure 13. The stick-fixed maneuver point was at approximately 29 percent M.A.C. at an indicated airspeed of about 350 miles per hour and a normal-force coefficient of 0.3 and moved aft with decreasing speed or increasing normal-force coefficient.

The stick-free maneuver points were also determined from figure 13 for an acceleration at the middle of the range covered at each speed. The stick-free maneuver points are the center-of-gravity positions where values of the slope dF_e/dn are zero in figure 13. The symbol n represents normal acceleration in gravitational units. The stick-free maneuver point for a 3g turn at 350 miles per hour was at approximately 28 percent M.A.C. and moved aft as the speed and acceleration decreased.

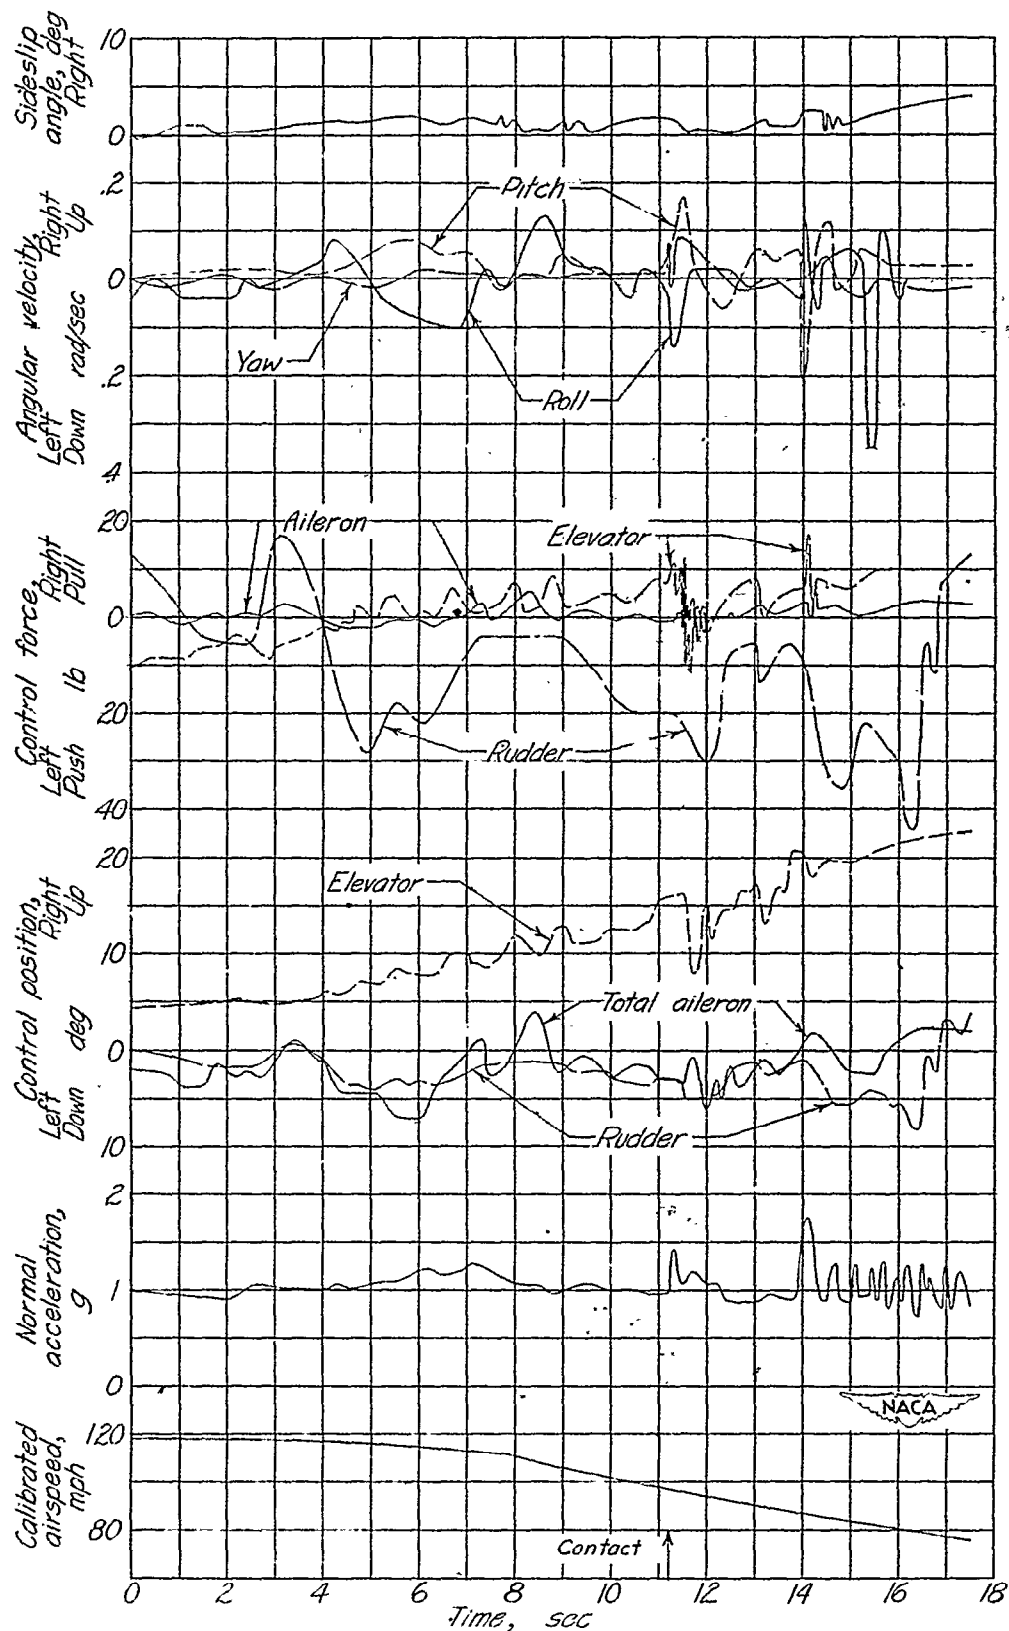
Figure 14.- Time history of a landing in the Grumman F8F-1 airplane.

Longitudinal control in landing.- The longitudinal control in landing was considered satisfactory. Figure 14 presents a time history of a typical landing from which it will be noted that with the center of gravity at approximately 24 percent M.A.C., landing gear down, about 16° up-elevator or about two-thirds of that available was used to land. Another landing record showed that, with the center of gravity at about 20 percent, approximately 21° up-elevator, or 3° less than that available, was required to land. Although in both cases it was not possible to trim the airplane below approximately 140 miles per hour, the elevator control forces were well below the maximum of 35 pounds considered satisfactory by the standards of reference 3.

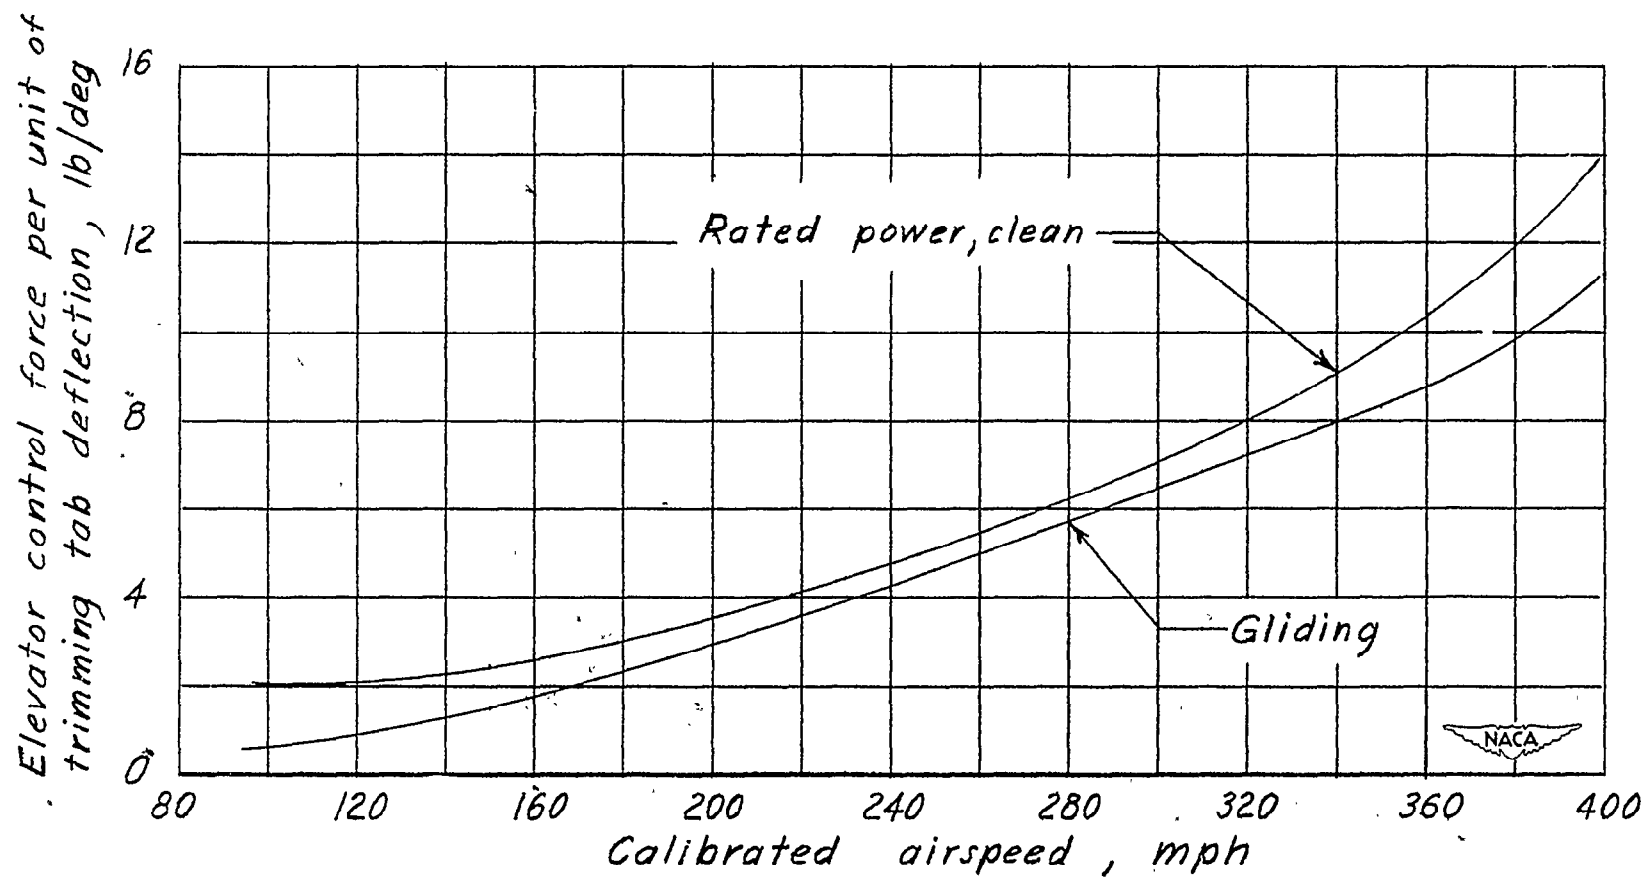
Figure 15.- Approximate power of the elevator trimming tabs, Grumman F8F-1.

Longitudinal trim control.- The variation with speed of the power of the elevator trimming tab in terms of pounds of control force per degree of tab deflection is presented in figure 15 for two flight

conditions. It was possible to trim the elevator control forces to zero throughout the test center-of-gravity range from the highest speed reached to within a few percent of the stalling speed for all but the landing condition. The minimum trim speed for this condition was about 140 miles per hour.

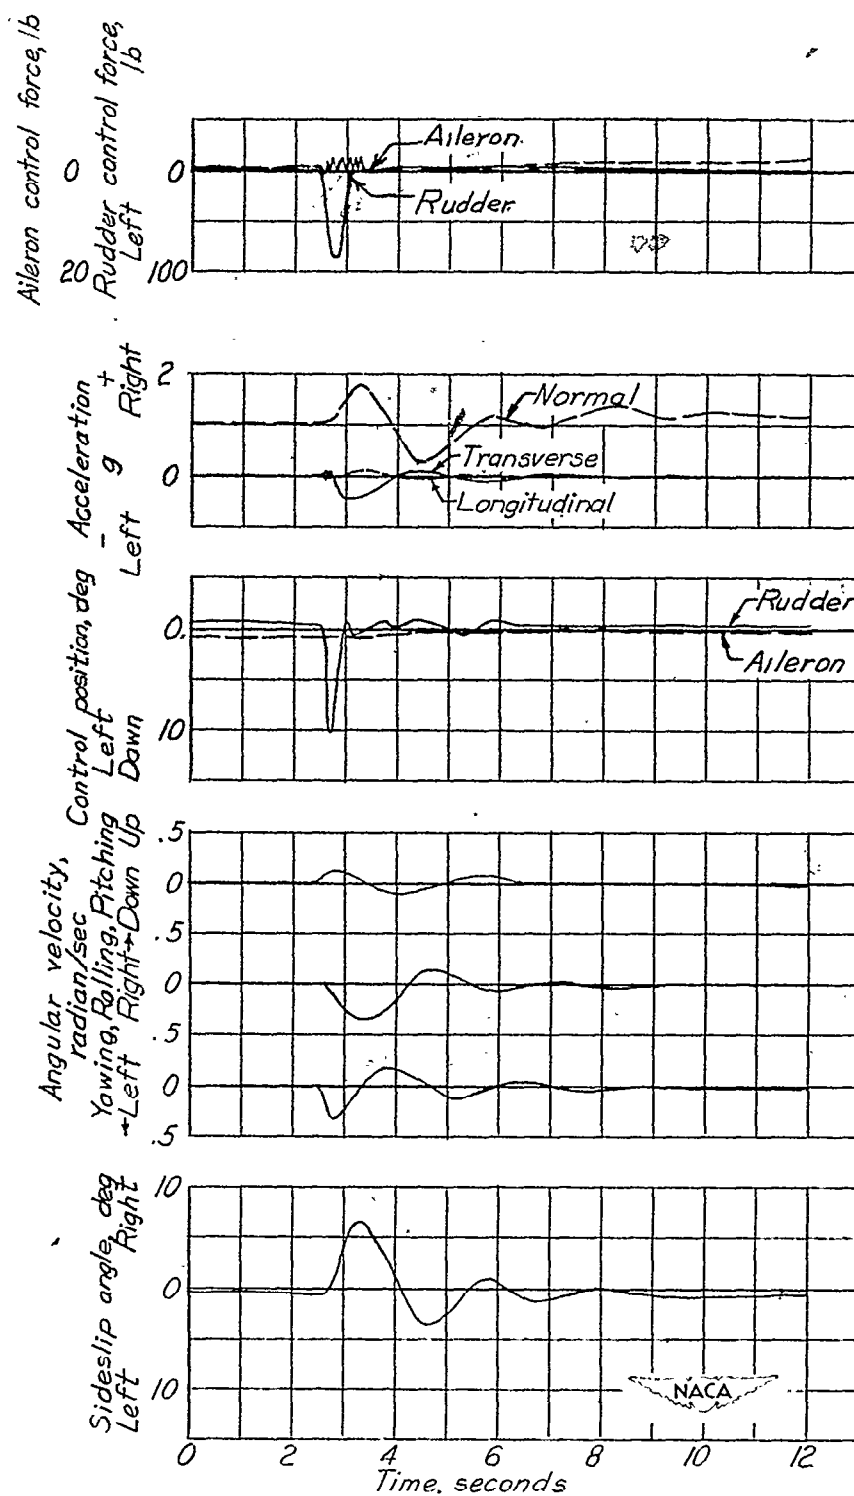
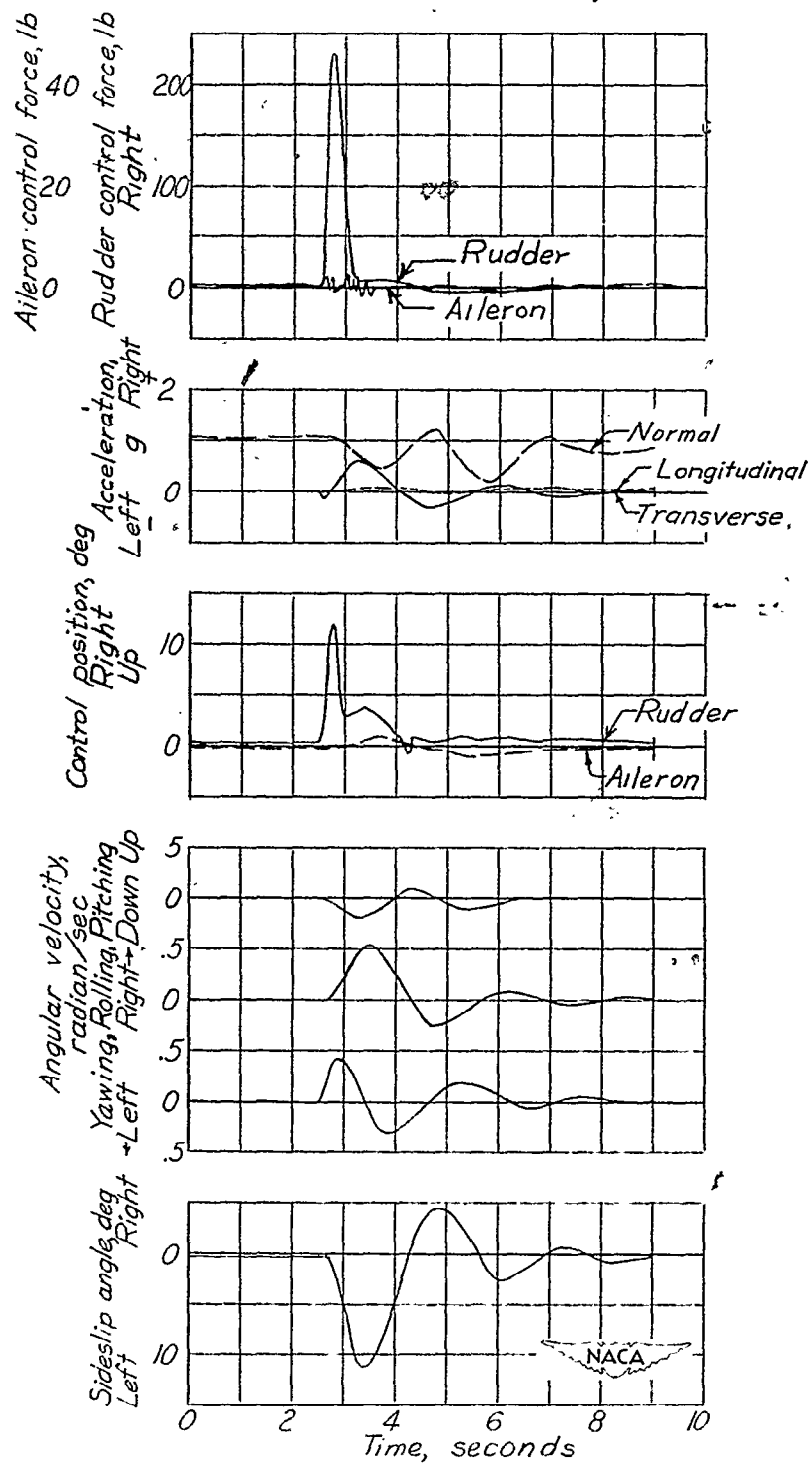
(a) Left rudder kick and release.

Figure 13.- Typical time histories of oscillations of the Grumman F8F-1 airplane in the clean condition with power for level flight (28-1/2 in. of Hg at 2500 rpm) at 290 miles per hour at an altitude of 5000 feet.

(b) Right rudder kick and release.

Pitching moment due to sideslip.- In the course of making rudder kicks and control releases from steady sideslips, the test pilot noticed changes in longitudinal trim causing the airplane to pitch. His findings were verified from a study of the test results which showed appreciable changes in normal acceleration and pitching velocity. To ascertain the extent of these effects, a few additional tests were made and the results plotted in figures 16 to 19. Typical time histories of oscillations

induced by rudder kicks are presented in figure 16, from which type of data the summary plot of figure 17 was obtained. In this figure, change in normal acceleration is plotted against change in rudder angle. It should be noted that the normal-acceleration changes which occur are dependent upon the time interval the rudder is held in the deflected position and, therefore, the values presented in figure 17 should be considered as only qualitative. The solid curves represent the first acceleration peak after the rudder is kicked. In left rudder kicks, the airplane initially pitched up but then pitched down more violently. The dashed portion of the curves represent this second peak. The pitching motion is caused by the combined effect of the gyroscopic action of the propeller and the pitching moment due to sideslip. In the case of right rudder kicks, both these effects tend to pitch the airplane down. In left rudder kicks, the airplane initially pitches up because of the gyroscopic moments, but then pitches down as the sideslip builds up. Figure 18 presents typical time histories of maneuvers in which the stick was released from steady sideslips with the rudder fixed. These results, therefore, isolate the effect of pitching moment due to sideslip. It is seen from this figure that the acceleration increased as the center of gravity was moved aft. From data of this type, the summary plot of figure 19, presenting change in normal acceleration against sideslip angle, was obtained. The large changes in normal acceleration due to release of the stick were considered unsatisfactory.

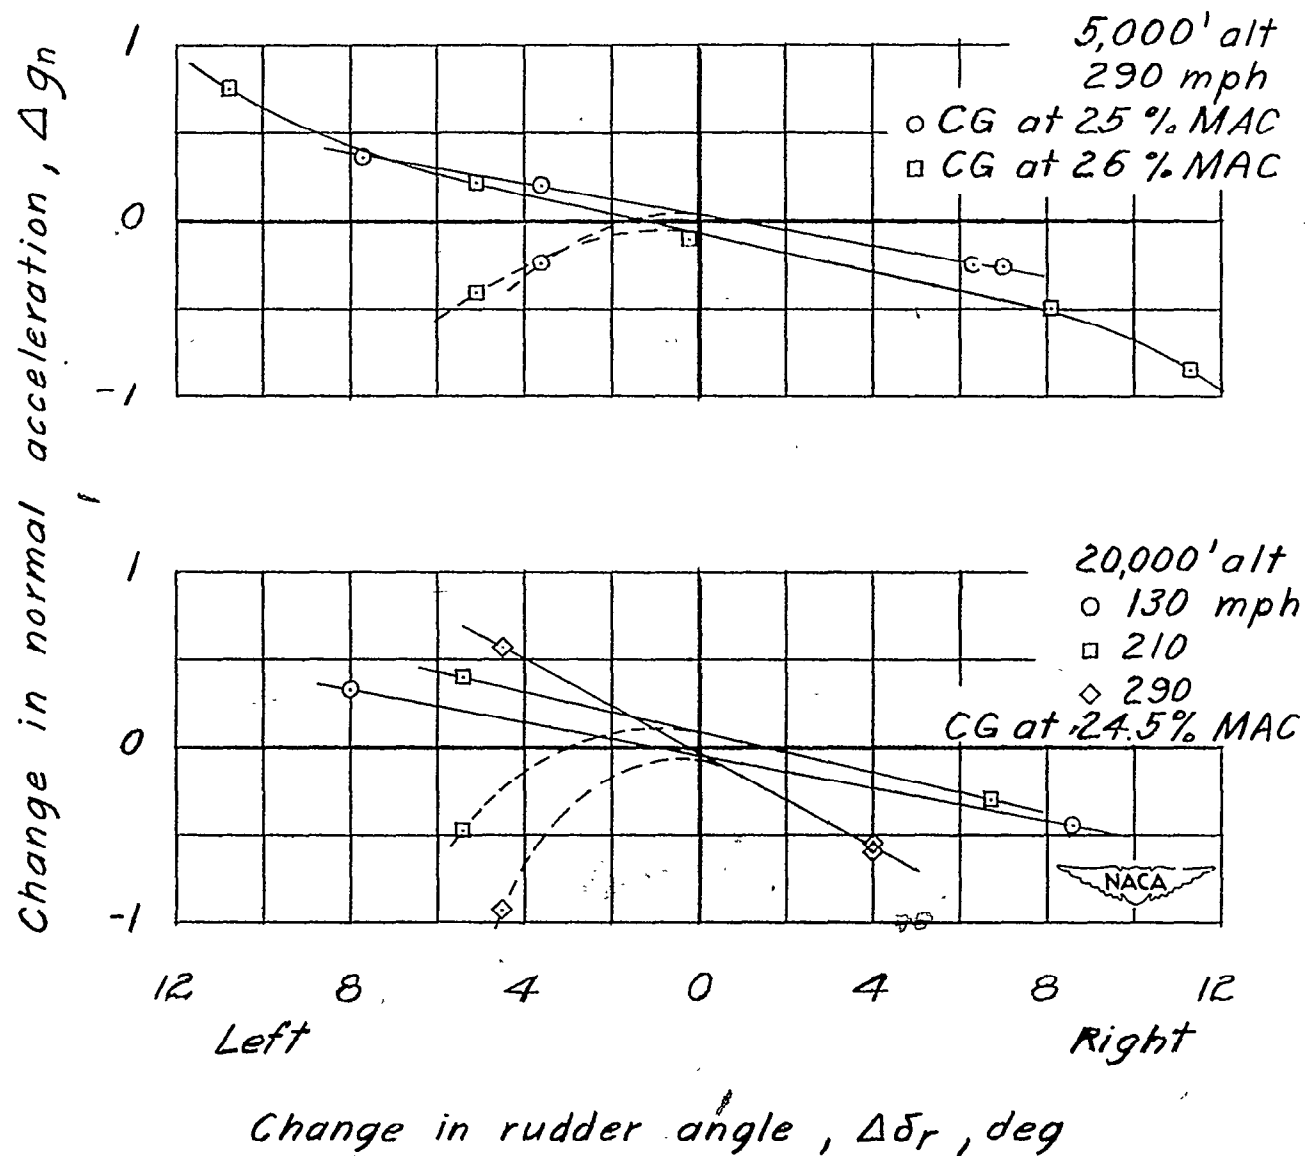
Figure 17.- Summary plot of the change in normal acceleration against change in rudder angle obtained in rudder kicks. Grumman F8F-1 airplane.

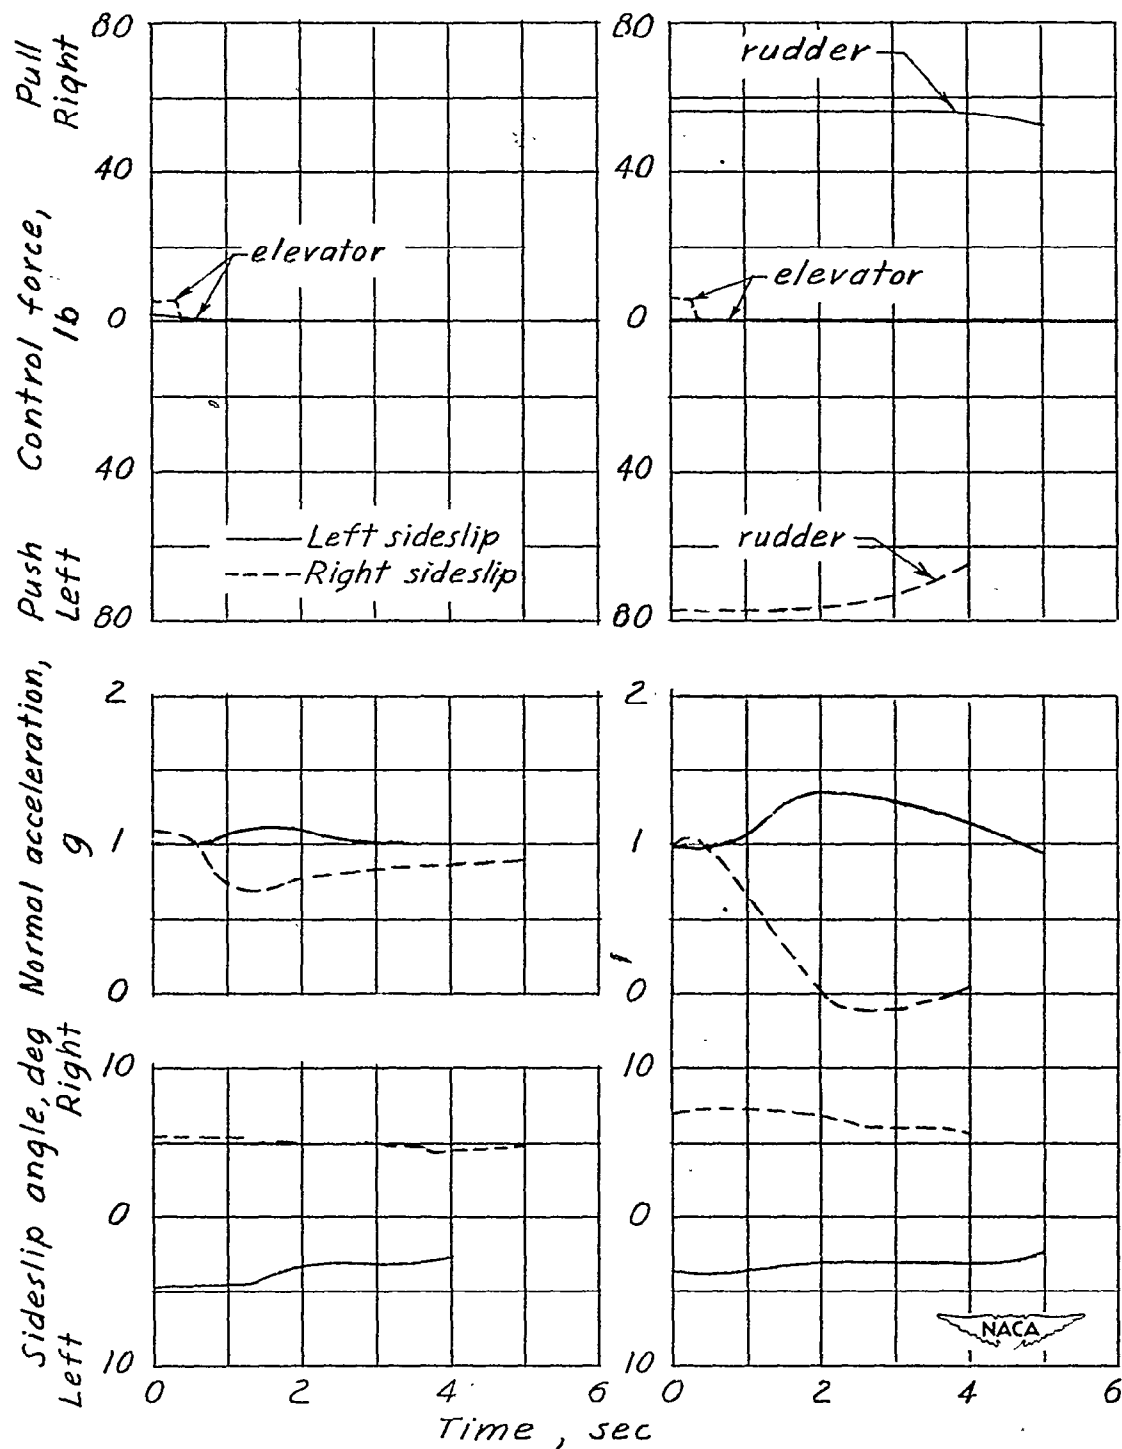
(a) CG at 19.8 percent M.A.C. (b) CG at 26.2 percent M.A.C.

Figure 18.- Typical time histories of releases from steady sideslips with the rudder fixed and the stick released. Grumman F8F-1 airplane.
